COMPOSITE REPAIR SPECIALIST

- **TYPE OF DEFECT :** Internal corrosion
- **PIPE DETAILS :** 44" ballast water line - max. operating temp. 25°C – design press. 6 barg
- **LOCATION :** EGYPT (Ain Sokhna)
- **3X PRODUCT :** REINFORCEKIT® 4D (R4D)

OVERVIEW

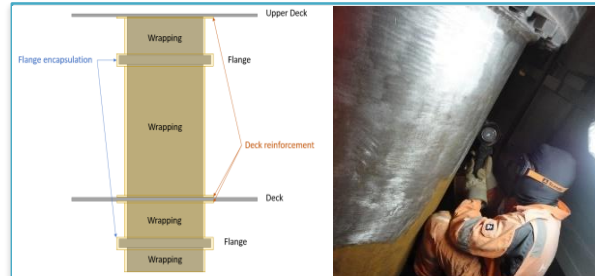
Design of the repair

- After calculations and Finite Elements Analysis (FEA), 8 layers have been determined to perform the reinforcement.

- Surface preparation was then completed by 3X team, using Bristle Blaster machine, to get a good surface roughness (superior to 60µm) and ensure the bonding between the steel pipe and the composite. Climatic conditions have been checked and the surface has been cleaned and degreased with Acetone.

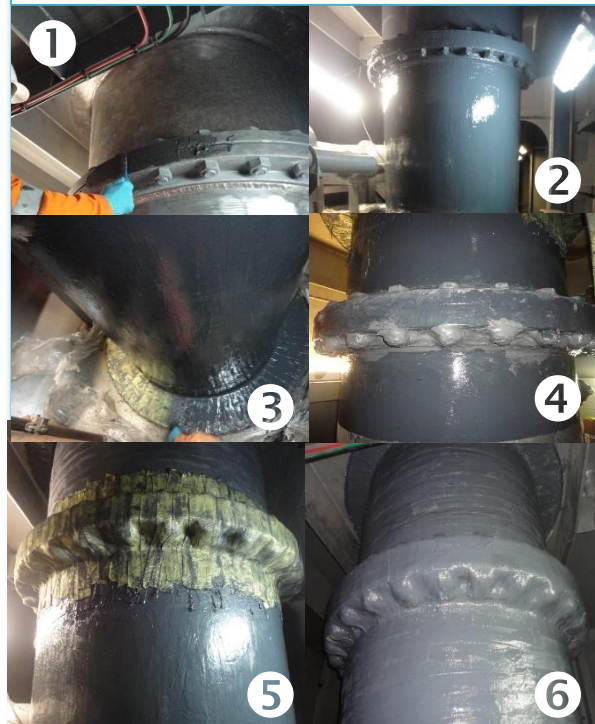
Composite repair steps

- 1/ F3XS1 filler application on flanges and deck weld.
- 2/ R3X5 resin application (1 layer) on the whole pipe surface to protect it from corrosion.
- 3/ Reinforcement process was then started on the deck weld using Kevlar® strips impregnated with R3X5 resin → 70 strips were necessary to make 1 pass all around the pipe (i.e. 2 layers). This step was repeated 4 times to reach the 8 layers.
- 4/ F3XCOMB filler application to encapsulate the 2 flanges and reshape their profile to facilitate composite application.
- 5/ Same reinforcement process was completed on flanges using Kevlar® strips and R3X5 resin → 87 strips applied for 1 pass (i.e. 2 layers). This step was repeated 4 times to reach the 8 layers.
- 6/ Wrapping process covering the total surface (i.e. straight part of the pipe and flanges) was finally completed using Kevlar® tape and R3X5 resin.

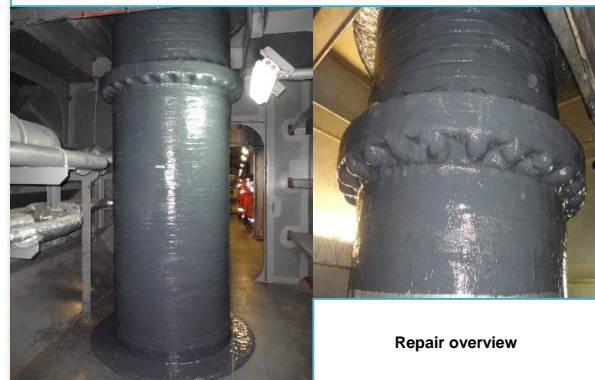
Repair overview

The 44" ballast line suffering from internal corrosion was successfully repaired using REINFORCEKIT® 4D. The total length of the repair was 4m. A special thanks to client team who helped us to work in the best conditions.
