Composite repair for damaged tank

Reboiler - 64" OD - max. operating temp. 130°C - installation temp. 80°C - calculated pressure 20 barg – design lifetime: 20 years

VIET-NAM - FPSO

REINFORCEKIT® PATCH

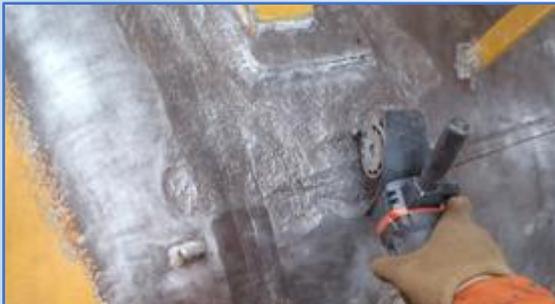
Figure 1: Surface preparation using Bristle Blaster machine

Surface preparation was completed, using Bristle Blaster machine, to remove coating and get a good surface roughness (between 60 µm and 100 µm anchor profile) to ensure a good bonding between the steel and the composite.

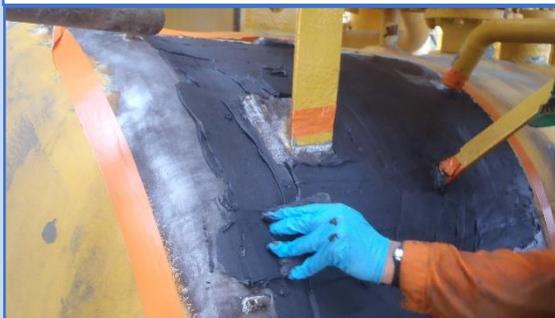
Figure 2: F3XS1 filler application on patch area

- 1 F3XS1 filler was applied on the patch area (previously delimited) to fill metal loss and reshape the tank side.
- 2 The surface was then covered with 3X specific epoxy resin (R3X1660) to ensure good wetting and impregnation of the Kevlar® tape.
- 3 First Kevlar® patch was applied on the wet surface using paintbrush and making sure to remove all air bubbles. The Kevlar® patch was then impregnated with R3X1660 resin in order to create the wet surface for the next patch. This step was repeated until the good number of layers was reached (4 layers/patches).
- 4 Final layer of epoxy resin was applied over the repair for protection.

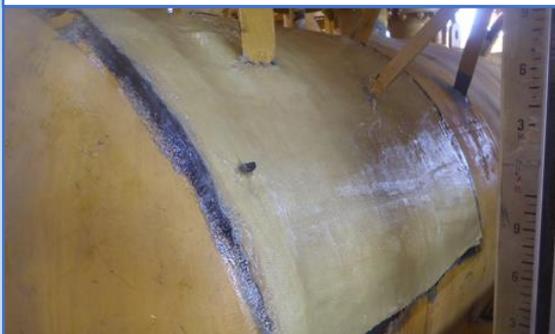
Figure 3: Composite patching finalized

After analysis of the corrosion extent, calculations according to ISO 24.817 were performed, concluding that 4 layers were needed to reinforce the reboiler. Because of the specific reboiler design, it was decided to use **REINFORCEKIT® PATCH** product, specially designed for tank & vessel repair → i.e. 4 Kevlar® patches size 1032x1032mm for this case.

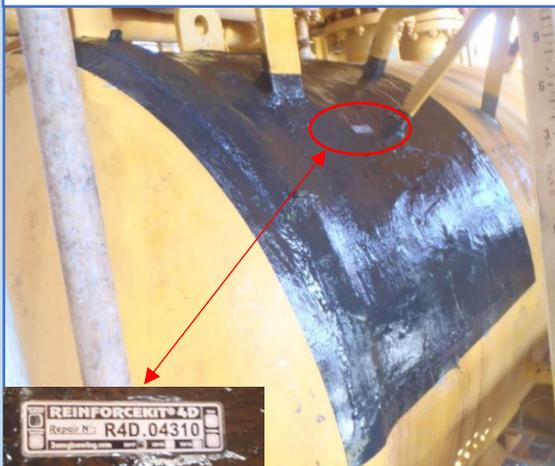
Figure 4: Final overview of the repair with ID plate

Identification plate was positioned on the tank for traceability.
