# COMPOSITE REPAIR SPECIALIST

- **TYPE OF DEFECTS :** Leaking crack & non-leaking crack
- **PIPE DETAILS :** 32" gas line – max. operating temp. 20°C – operating pressure 1160 psi (80 bar)
- **LOCATION :** MIDDLE-EAST
- **3X PRODUCT :** REINFORCEKIT 4D SUBSEA (R4D-S)

The objective of the repair performed in August 2017 by 3X ENGINEERING (3X) and its local distributor was to **seal 2 cracks and reinforce the pipe integrity at 70-meter depth**.

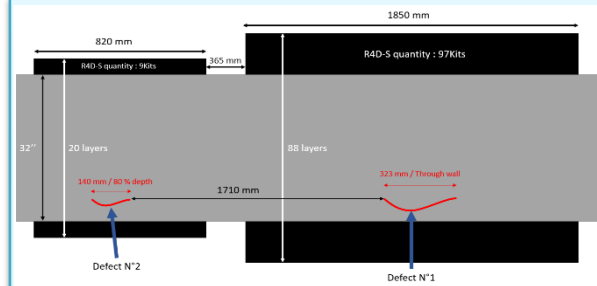
- According to ASME PCC-2 and 3X repair calculations, it has been decided to make 2 different repairs as shown in Figure 1. Eighty-eight composite layers of **REINFORCEKIT 4D SUBSEA (R4D-S)** product have been determined to repair Defect No. 1 (external crack with through wall section) and 20 layers for Defect No. 2 (non-opened crack).

Fig. 1: Design of the repair

5/ Kevlar® tape pre-impregnated with R3X1050-S resin (using special devices developed by 3X) wrapped around the pipe. Eighty-eight layers were necessary to repair Defect No. 1 (i.e. 44 passes of 50% overlap for 1,85-meter length repair). For Defect No. 2, 20 layers were applied (i.e. 10 passes of 50% overlap for 0,82-meter length repair).

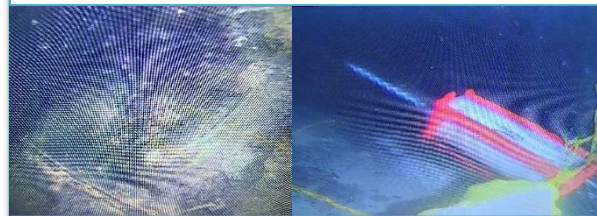
Fig. 2: F3XUW9 filler application

1/ For both defects, F3XUW9 filler has been applied to fill the cracks and reshape the pipe geometry.
