Innovating pipeline integrity

**Laurette Sapin Cuiret,
3X ENGINEERING, Monaco, discusses
advanced composite technology for
corrosion repair on pipelines.**

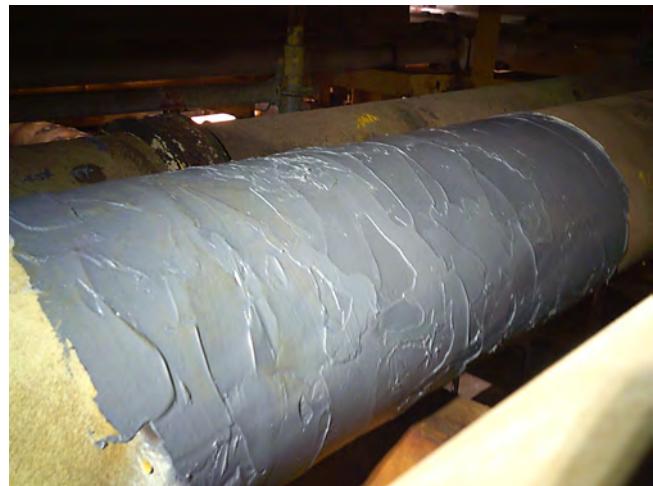
Figure 1. Case study 1: surface reconstruction with filler.

In May 2025, an 8 in. crude oil washing line on a FPSO unit presented multiple defects, including five corroded areas and

four leaks. The line operated at a temperature of 60°C and a pressure of 16 bar, conditions that required an immediate, robust repair to prevent environmental risks and costly shutdowns.

- Leak sealing: a specific metallic and filler device was installed to seal active leaks before wrapping.
- Surface reconstruction: a high-performance filler was used to rebuild the pipe geometry.
- Resin application: the first layer of epoxy resin ensured strong adhesion between the substrate and the composite wrap.
- Composite wrapping: Kevlar tape layers impregnated with resin were applied to provide structural reinforcement.
- Finalisation: a final resin coating sealed the repair and an identification plate was installed for traceability.

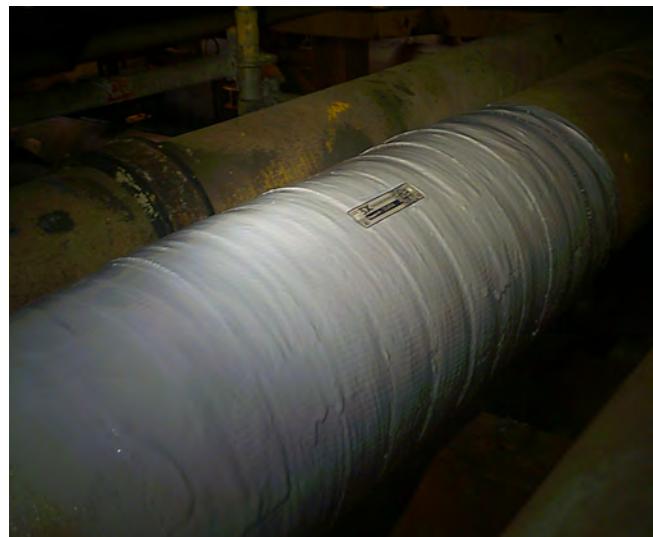
Figure 2. Case study 1: repair overview.

The intervention fully restored the mechanical integrity of the line. The repair successfully withstood operational pressure and temperature without leakage. By using an advanced composite solution, the operator avoided production interruption, reduced safety risks, and extended the pipeline's service life.

In compliance with ASME PCC-2 standard, the composite repair solution specified the use of Kevlar tape impregnated with bi-component epoxy resin. The procedure involved:

- Four layers of composite applied over areas affected by corrosion.
- 10 layers applied over through-wall defects.

To ensure adhesion, the surface was prepared using Bristle Blaster® machine to achieve cleanliness equivalent to St3/SA 2.5 and a surface roughness greater than 60 µm (Rz). Once prepared, the area was degreased with acetone and the composite reinforcement was applied through several key stages:

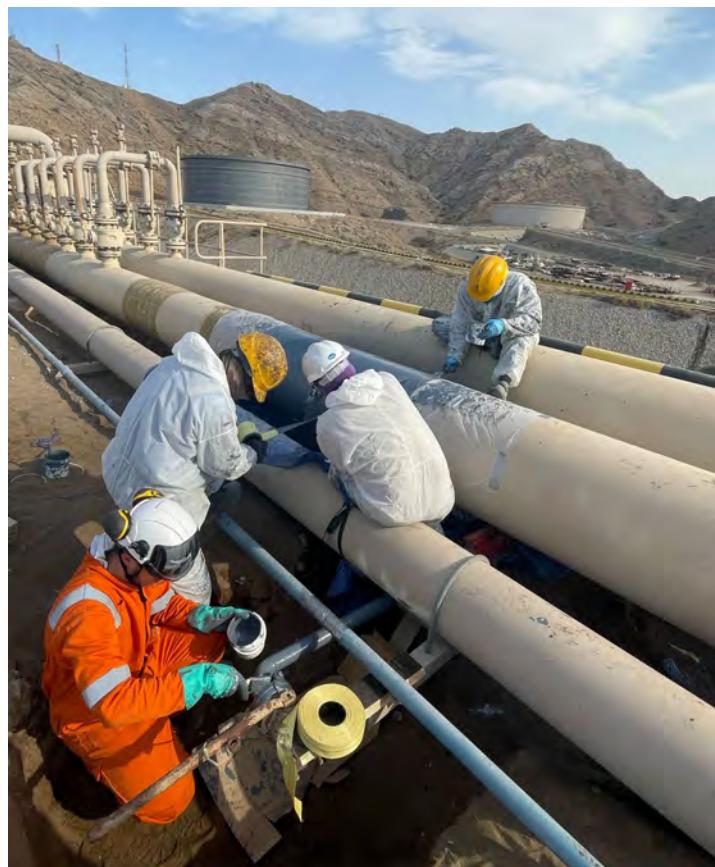
In April 2025, specialists were tasked with repairing a 24 in. pipeline and a 2 in. elbow within an onshore tank farm. The assets had suffered from internal corrosion, resulting

in seven localised defects that compromised structural reliability. The client looked for a long-term solution that could be implemented rapidly and without major operational disruption.

Figure 3. Case study 2: composite wrapping on progress.

- Primer application: a high-performance epoxy resin layer was first applied to create a strong adhesion base.
- Composite wrapping: four layers of Kevlar tape impregnated with resin were wrapped around each defect. The total repair lengths varied by location:
 - 600 mm for one straight-line defect.
 - 1350 mm for a second straight-line defect.
 - 820 mm for the 2 in. elbow.
 - 600 mm each for the remaining four locations (straight line).
- Final coating: a final resin layer was applied to seal the system and ID plate was installed for traceability.

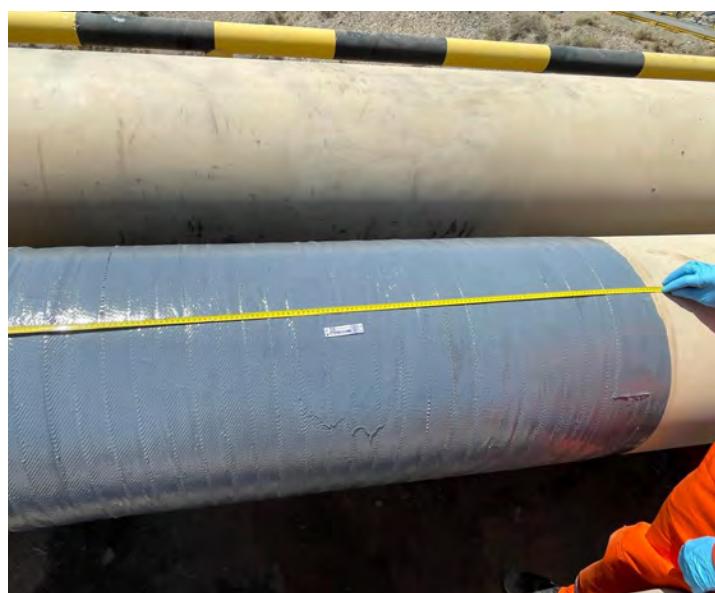
Figure 4. Case study 2: repair overview.

Resin samples were collected during installation for quality control and post-repair hardness testing confirmed that the material achieved full curing and mechanical strength. The results demonstrated successful pipeline restoration.

Surface preparation was carried out using sandblasting to achieve a surface roughness exceeding 60 µm (Rz), ensuring proper bonding between the steel substrate and the composite material.

To enhance durability, the client was advised to apply an anti-UV coating after a 72 h curing period. The repaired sections returned to normal operation without any reported issues, confirming the reliability of composite repair technology for internally corroded pipelines.
