DEFECT TYPE	Internal metal loss
PIPE DETAILS	16" gas line – max. op. temp. 45°C – op. pressure 125 bars
LOCATION	VIET-NAM
3X SOLUTION	REINFORCEKIT® 4D SUBSEA (R4D-S)

The objective of the repair, performed in May 2018 by 3X ENGINEERING (3X) and its local distributor PETROENERTECH, was to **reinforce a 16" subsea pipe suffering from internal corrosion at 45-meter depth.**

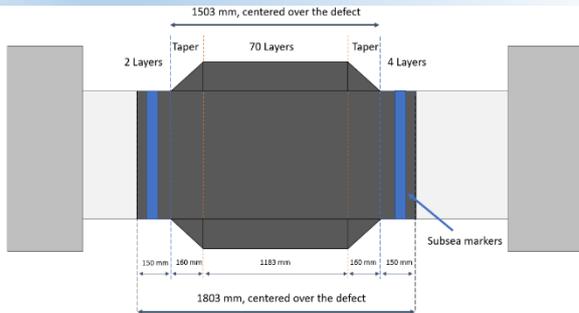
Figure 1: Design of the repair

According to ASME PCC-2 and 3X repair calculations, 70 layers of R4D-S have been determined to repair the defect.

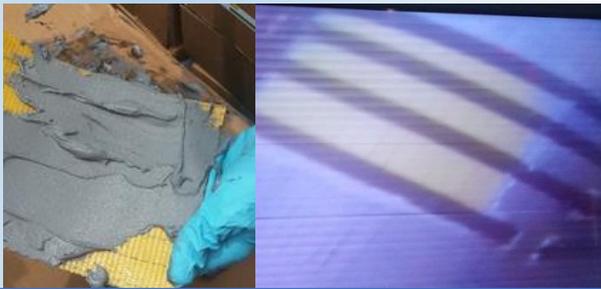
Figure 2: Preparation of the composite plate with filler
Figure 3: Plate installation with ratchet belts

- ① Preparation of the composite plate recovered with **F3XSS filler** and application over the defect using ratchet belts for tightening (after 2 hours of curing, the belts were removed).

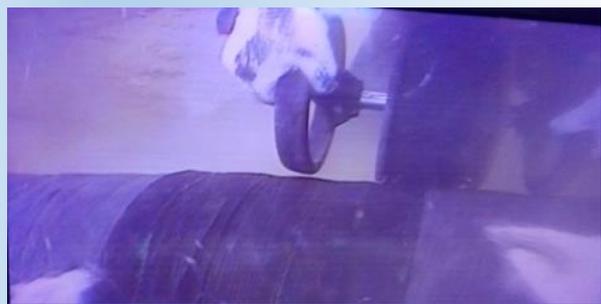
Figure 4: Composite wrapping in progress

- ② **P3X32 primer** application on the whole area to be repaired before wrapping to ensure a good bonding between the steel pipe and the composite.
 - ③ Kevlar® tape impregnated with **R3X1050S resin** and wrapped around the pipe. The tape impregnation is performed using BOBIPREG (3X specific machine allowing a quick and regular impregnation resin/fiber). Seventy layers were necessary to repair the defect (i.e. 35 passes of 50% overlap) for a total repair length of 1503mm.

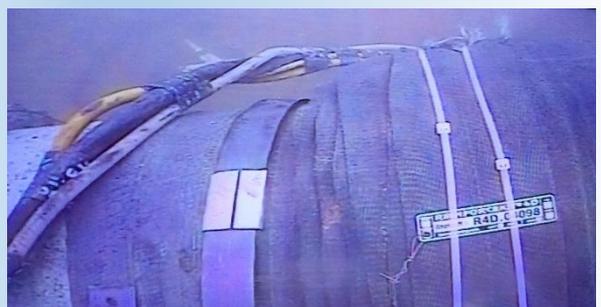
Figure 5: Subsea markers and reference plate installed

- ④ Specific **subsea markers** installation on the composite (to avoid any contact with the pipe), on each side of the repair. For that reason, it was necessary to increase the length of the repair of 150mm each side to be able to install these markers.

- At client's request, 3X has created and installed these subsea devices to localize easily the defect at pigging inspection.
- ⑤ Finalization of the repair with reference plate positioning for traceability purpose and protective cover application over the repair to protect the pipe from subsea aggressions.
