Online repair  
for SF6 leaking flange

SF6 gas leakages on flanges

Open cone insulators – tension 400 kv - pressure 5.2 bars – temp. 25°C

SAUDI ARABIA

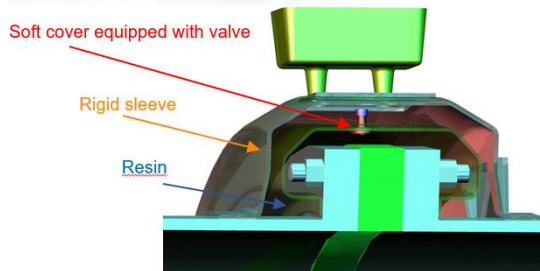
Figure 1: **REFLANGEKIT®** Concept

After data analysis and onsite inspection, it was decided to repair the flanges using our **REFLANGEKIT®** product specifically designed to seal SF6 gas leakage online.

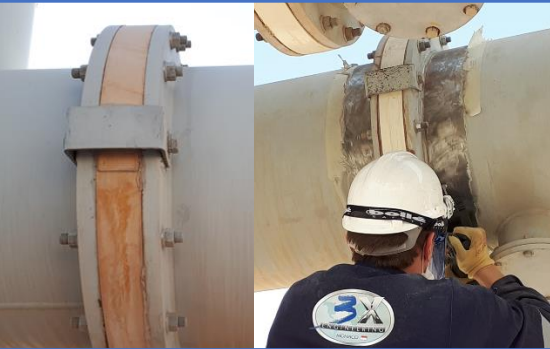
Figure 2: View of flange type to be fixed

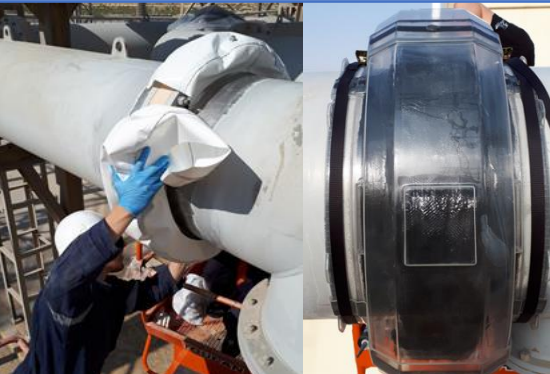
Figure 4: Soft shell installation

- 1 Preparation and installation of the soft shell around the defected flange. The goal is to protect all the functional parts and to concentrate the SF6 gas leak in a single point located on the top (= the valve).

- 2 Insulation and compression of the soft shell using specific 3X filler and adhesive tape.
- 3 Composite reinforcement is then performed with glass fiber impregnated with 3X resin.

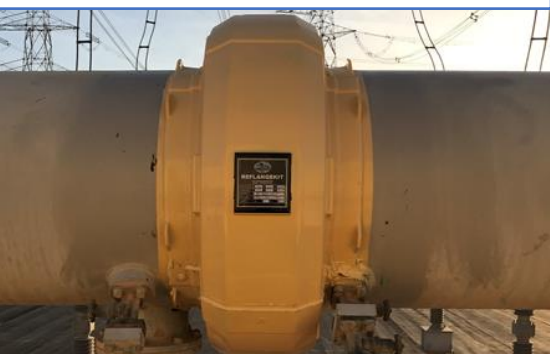
Figure 6: **REFLANGEKIT®** installed and recovered with protective coating

- 7 The flange repair is finalized recovering the valve with resin. The **REFLANGEKIT®** is then painted with a protective coating and an
