DEFECT TYPE
PIPELINE DETAILS
LOCATION
3X SOLUTION

Pinhole – 6” subsea gas pipeline – 30m depth
Bend – pressure 900 psi – temperature 30°C
INDONESIA (Client Platform)
STOPKIT® Offshore (STOF006)

OVERVIEW

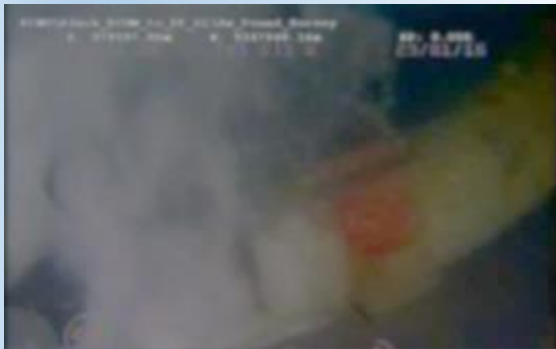
The objective of the EPRS (Emergency Pipe Repair Solution), performed early 2017 by the client, was to stop an on-line gas leakage located at one of the bend of 6” subsea line.

Figure 1: Bend with the leak

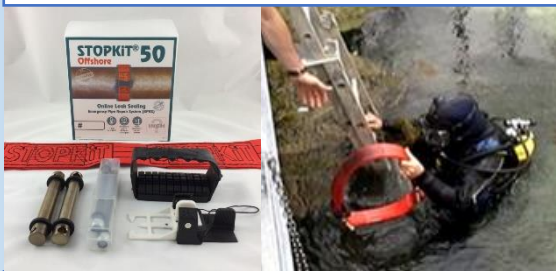
Figure 2: **STOPKIT® Offshore** Packaging

After inspection, it was decided to stop the leakage of the 6” subsea gas line. As per their EPRS procedures, the client picked one of their several **STOPKIT® Offshore** available on the platform (no procurement delay - immediate solution available).

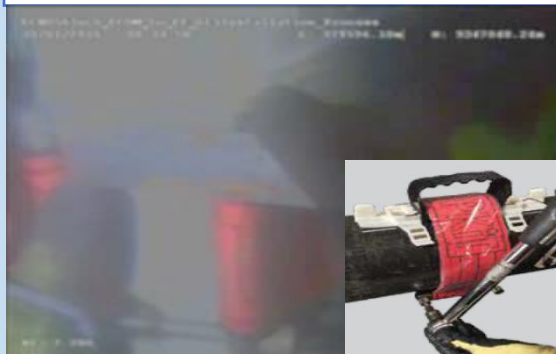
Figures 4 & 5: Once well positioned over the leak, both screws of **STOPKIT®** must be tightened at 40 Nm

- 1 Position the **STOPKIT® Offshore** next to the leak using our **STOPKIT®** Positioner device and tight softly to let a free sliding capacity.
- 2 Slide the **STOPKIT® Offshore** over the leak. Rubber patch must be perfectly centred on the leak thanks to our **STOPKIT®** Positioner device.
- 3 Tight alternatively the right screw and the left screw to keep the two bars parallel. Repeat until torque reaches 40 Nm for both screws.
- 4 Screw anti-vibration nuts.

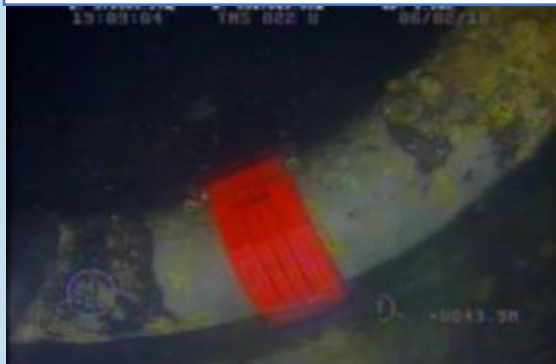
Figure 6: **STOPKIT®** successfully installed on the bend
No more gas bubbles, no more leak

The leak has been rapidly stopped despite the bend as challenging location. This proves the capabilities of our **STOPKIT®** to efficiently control on-line leakage. This solution is only temporary. It allows you to fix the emergency and schedule peacefully for permanent repairs in the upcoming weeks or months.
