## 3X Engineering's composite repair

3X Engineering's composite repair

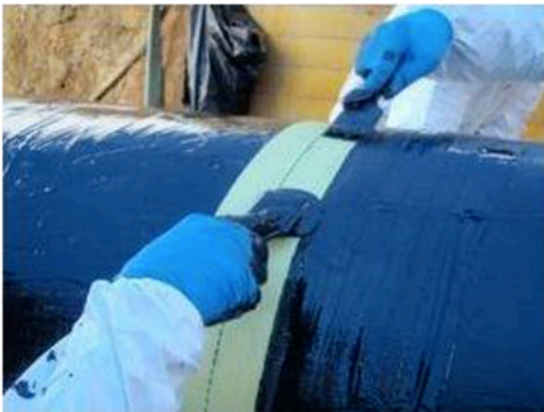
An onshore transfer 24" pipeline was damaged by an excavator causing a large dent and a leak. The pipeline reinforcement was performed in April 2014 by 3X Engineering (3X) team.

The pipe was fully flooded with water. The leak sealing was done by using arc welding. F3X8 filler (3X) was applied at the welding area. The dent and its gouges were also filled in with this filler.

Type of Defect:	dent, gouges and leak
Pipe size:	24" OD (API5L grade B, t=8.1mm)
Nominal pressure:	12.66 bar
Pipe temperature:	60 deg C
Client:	Foselev Agintis
Location:	La S.A.R.A. (Martinique)
3X Product:	Reinforcement 4D (R4D)

As this pipeline operates between ambient and 60°C temperature, the R4D-IC kits were used. Aramide tape was impregnated with R3X5 resin (3X) and helically wrapped with 50% tape overlap. Curing time of 72 hours was done prior to hydrotest at 10 bar pressure.
