Pigging Industry News

the newsletter of the Pigging Products & Services Association

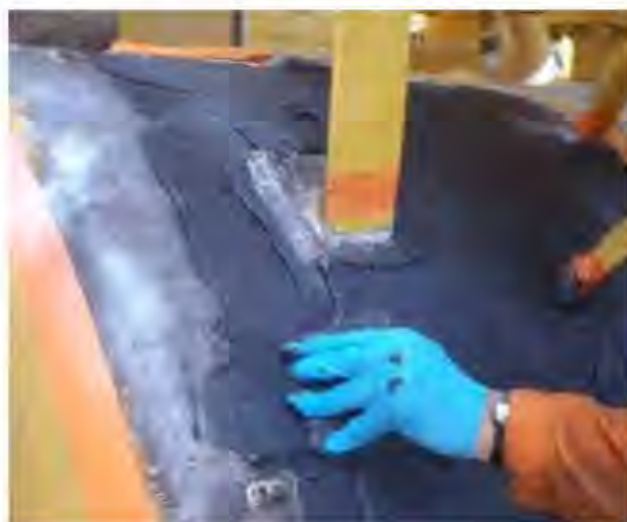
F3XS1 filler application on patch area

In August 2017 3X ENGINEERING (3X) and its local distributor PETROENERTECH performed a repair to reinforce a reboiler located on FPSO suffering from external corrosion. After analysis of the corrosion extent, calculations according to ISO 24.817 were performed, concluding that 4 layers were needed to reinforce the reboiler. Because of the specific reboiler design, it was decided to use REINFORCEKIT® PATCH product, specially designed for tank & vessel repair i.e. 4 Kevlar® patches size 1032x1032mm for this case.

Surface preparation was completed, using Bristle Blaster machine, to remove coating and get a good surface roughness (between 60 µm and 100 µm anchor profile) to ensure a good bonding between the steel and the composite. Before composite patching, dew point, moisture and surface temperature were checked and the surface was cleaned and degreased.

Composite repair was performed as follows:

- F3XS1 filler was applied on the patch area (previously delimited) to fill metal loss and re-shape the tank side.
- The surface was then covered with 3X specific epoxy resin (R3X1660) to ensure good wetting and impregnation of the Kevlar® tape.
- First Kevlar® patch was applied on the wet surface using paintbrush and making sure to remove all air bubbles. The Kevlar® patch was then impregnated with R3X1660 resin to create the wet surface for the next patch. This step was repeated until 4 layers/patches was reached.
- Final layer of epoxy resin was applied over the repair for protection.
