Reinforcement of corroded overhead contact line masts

Alexandre Machet, Jean-Paul Mentel, Paris (FR); Stanislas Boulet d'Auria, Monaco (MC)

Significant corrosion was detected on French Railway Network's contact line supports. In order to restore and maintain the performance of those masts, SNCF and the 3X Engineering Company developed a method aiming at restoring the supports. This method combines metallic materials and composite reinforced resin. The contact line mast repair applying composite materials allows to regain their initial performance and to diminish the logistical efforts for reconstruction as well as the costs involved.

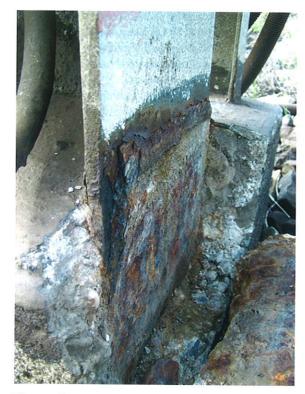
Figure 1: Typical example of corroded mast in French network (photos 1, 2, 3, 5 and Figure 6: SNCF).

For many years, the SNCF has been facing a significant level of corrosion on their contact line masts in specific geographical areas. This corrosion may be caused by saline sprays. Without the intervention of strength maintenance crew, the corrosion would deteriorate the masts due to a diminution of its strength (Figure 1 and 2).

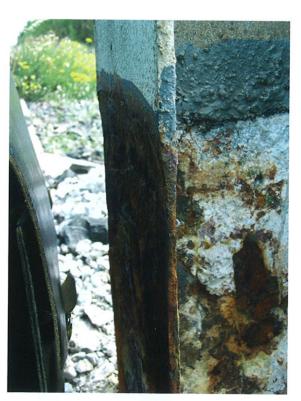
Figure 2: Typical example of corroded mast in French network.

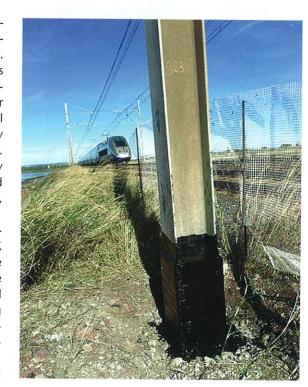
Figure 3: Conventional mast reinforcement.

3X Engineering's proposal which was developed further and patented by SNCF combines materials and technologies to an optimum solution concerning quality and costs (Figure 3).

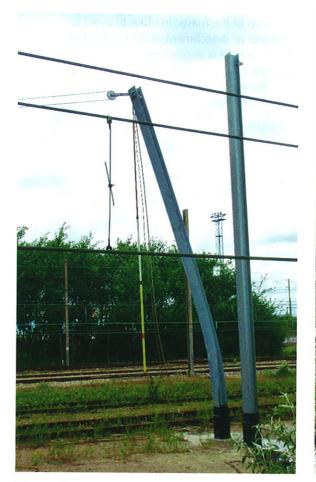
Figure 5a: Testing of a reinforced H-type mast.

Some tests were carried out as a part of the validation of the reinforcement process mast sections. Thus, masts were errected on SNCF testing station. The tests involved estimating the mast reaction under mechanical loads applied at the mast head (Figure 5a)). The tested masts were:

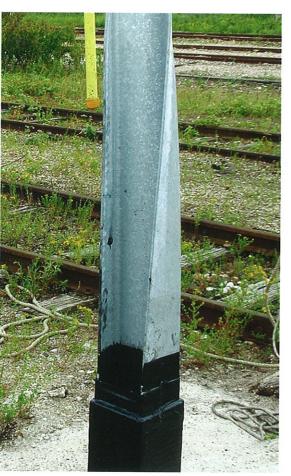
Figure 5b:Performance of the reinforced part of H-type mast after testing.

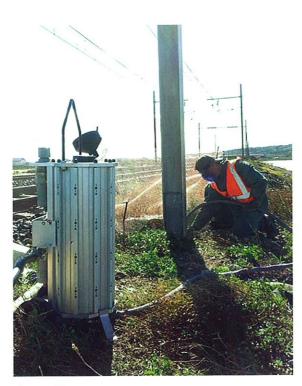
Figure 7a: Preparaton of mast surface (step 1).

- Step 1: Preparation of the mast's surface by shot-blasting with a minimum roughness profile of 60 µm in order to ensure the adhesion of the reinforcement on the mast and the emerging part of the concrete. It is realised by sandblasting or grit blasting tool (Figure 7a)).

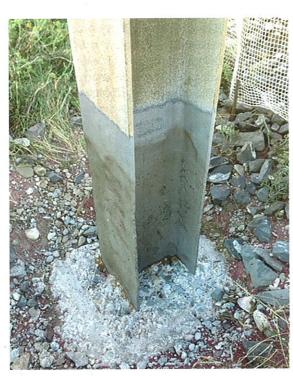
Figure 7b: Mast pepared for repair (step 2).

- Step 2: Re-aggregation of the cankers due to corrosion by application of an epoxide mastic. This mastic ensures the transmission of contact line mast's stresses to the inserts constituting the reinforcement (Figure 7b) and c)). The mastic's role is also to ensure the cold welding of the four inserts.

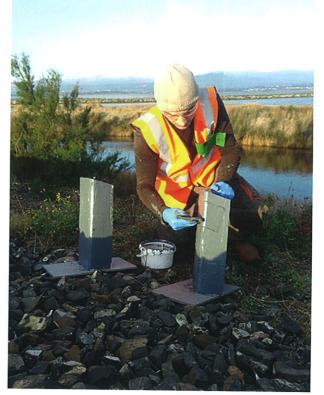
Figure 7c: Preparation of inserts (step 2).

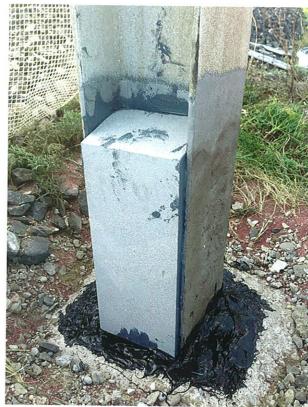
Figure 7d: Reparation of inserts (step 3).

- Step 3: Implementation of the four inserts. Size and nature of the chosen materials are related to their mechanical and physical characteristics (Figure 7d)).

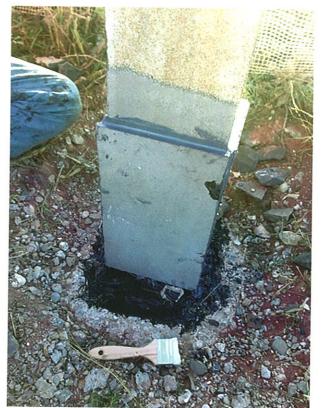
Polymerization of the mastic (step 3).

- The unit of blocks and slabs is maintained thanks to straps during the time of polymerization of the mastic in order to avoid any risk of gap or detachment of the inserts (Figure 7e)).

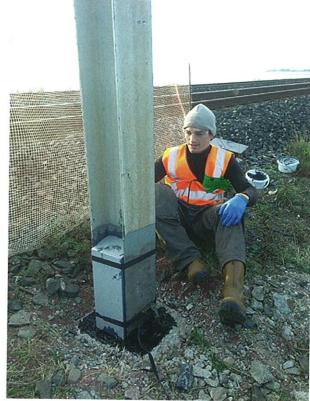
Figure 7f: Application of resin (step 3).

- The resin is applied on the emerging part of the mast with a particular attention given to the mast embedment part (Figure 7f)).

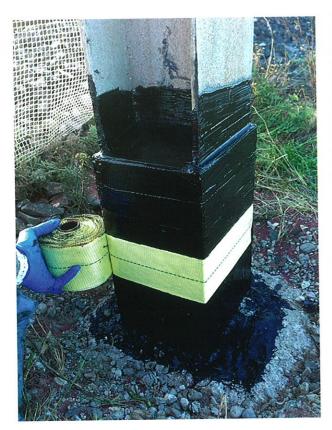
Figure 7g: Wrapping the Kevlar® strip on the repaired mast (step 4).

- Step 4: Wrapping of the whole repair with a Kevlar[®] strip soaked in an epoxide resin.
 - Several coats are made; the wrapping is carried out from the base to the top with a constant covering of about 50% (Figure 7g)).
- The top zone of inserts is machined with a slope in order to present an angled top face to avoid any risk of stagnant water.
- Step 5: Application of an elastomeric resin which guarantees a protection against UV and other impacts (Figure 7h)).

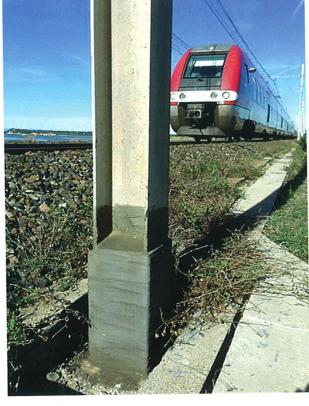
Figure 7h: Repaired mast (step 5).

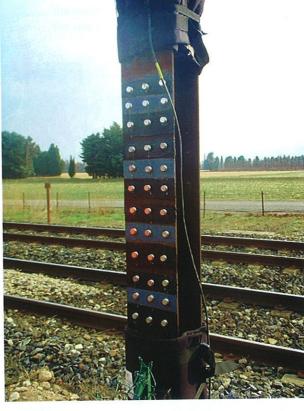
Figure 9: Preliminary study on restoration of a corroded mast made of CORTEN steel to select the most appropriated resin.

A new campaign is being prepared and will concern the contact line masts of the line Miramas to Avignon. The 54 masts concerned by this campaign were realised in CORTEN type steel.

A preliminary analysis of the supports (Figure 9) allowed to prepare the masts and to select the most appropriated resin. The implementation is scheduled for September 2014.
